# Statue of Liberty: A Risk Analysis

Bruce Campbell, FSFPE  
*VP – DOE Services*

**National Park Service**

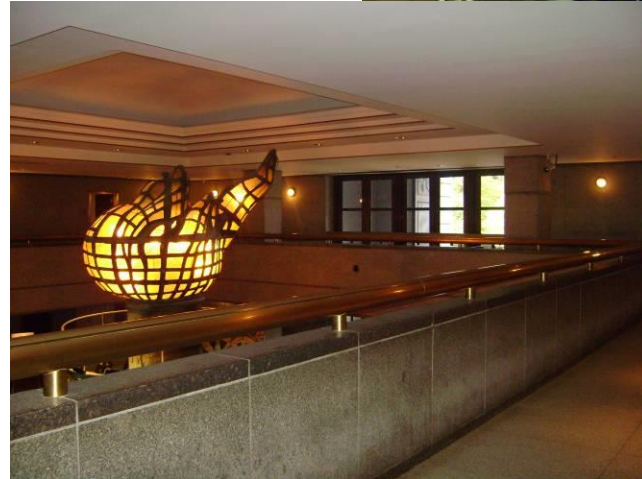
- Statue construction is not compliant.
  - Copper on unprotected iron skeleton
  - Fire resistive construction required
- Vertical openings are not compliant.
  - Main lobby area
  - West lobby stair (open at 2P)
  - Pedestal core (1P-6P)
  - Statue (7P-Crown)

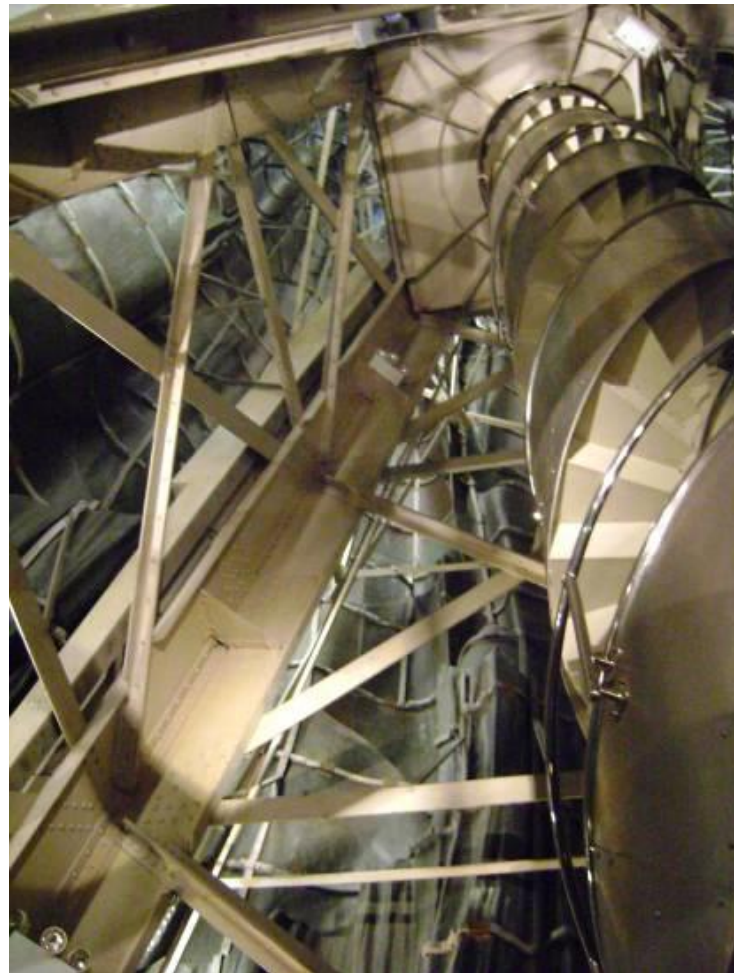
## Statue (7P – Crown)

- Codes do not specifically address.
- Potentially classified as mezzanine.
  - Common path of travel >75 ft.
  - Enclosed stair or 2 means of egress.

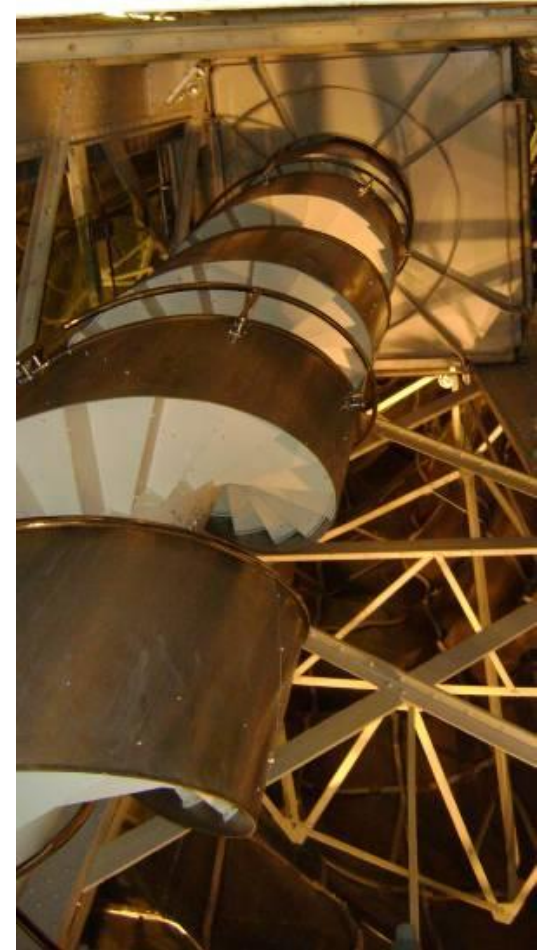
- Most stairs-noncompliant
- Several egress doors-noncompliant
- Ramp at sally port exit-noncompliant
- Unique issues-stair / door to Level 7P and double-helix stair to Crown
  - Two intertwined spirals; one leads down the other goes upwards

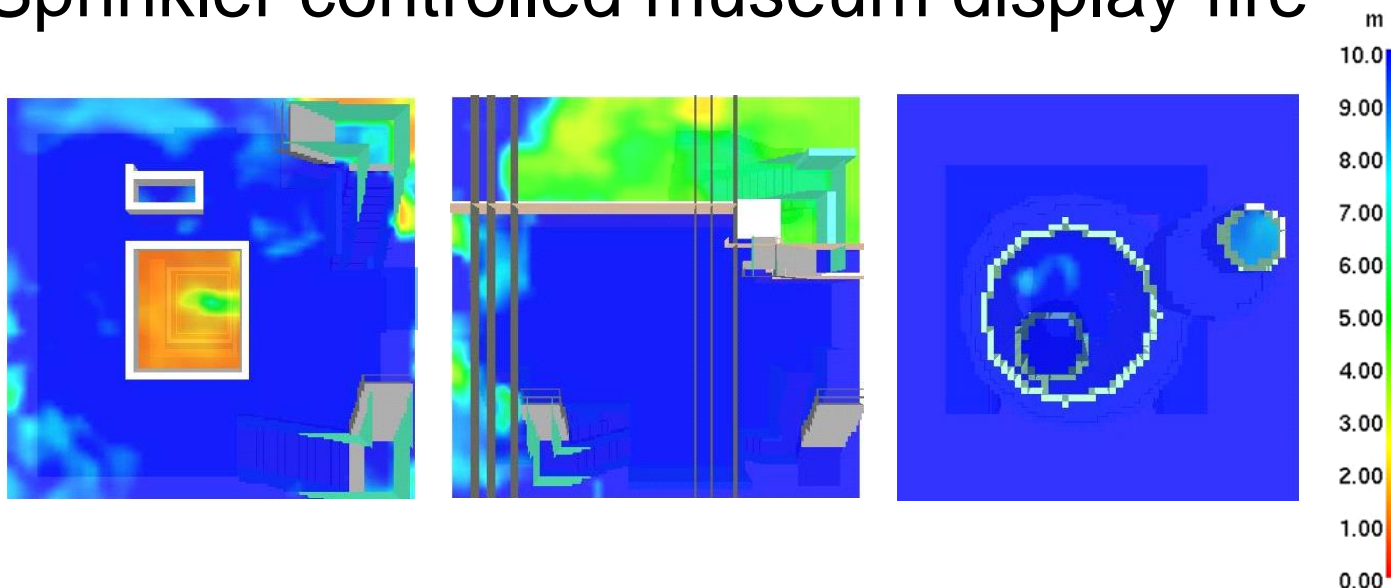
3P - 690 sec

6P - 810 sec

Crown - 910 sec

Detection [sec (min)]	Approx. Time to Reduced Visibility [sec (min)]		
	3P	6P	Crown
22 (0.4)	690 (11.5)	810 (13.5)	910 (15.2)

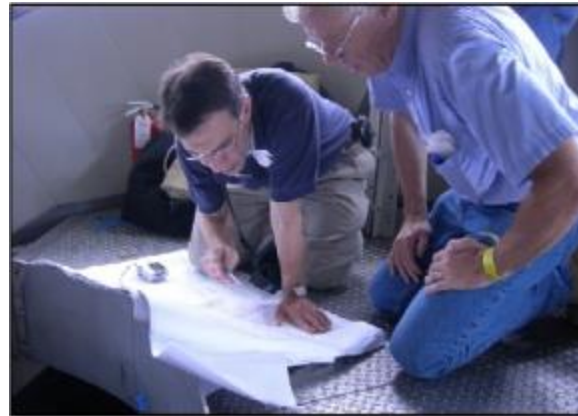
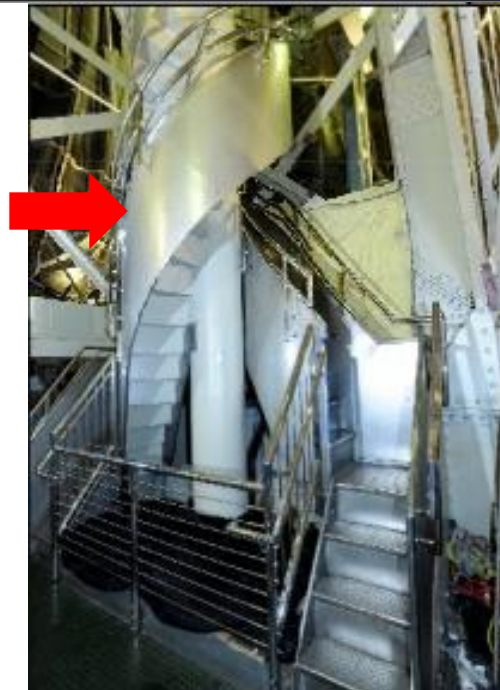
- Improvements were made to the helical stair to allow guided tours to the crown.
  - New construction basically separates each floor of Pedestal into two separate stairs and an elevator lobby.
  - Crown was re-opened to public on July 4, 2009.
- The Statue of Liberty was closed for renovations to the pedestal.
  - Re-opened – July 4, 2013

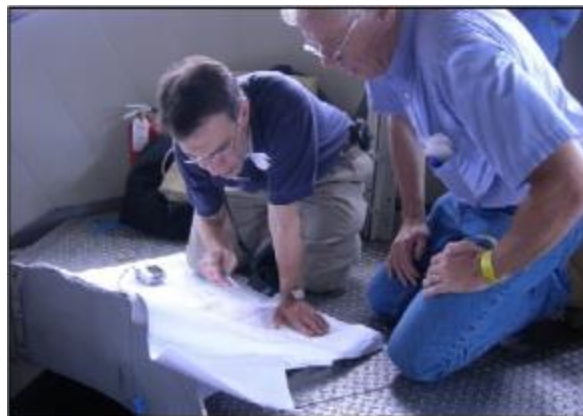
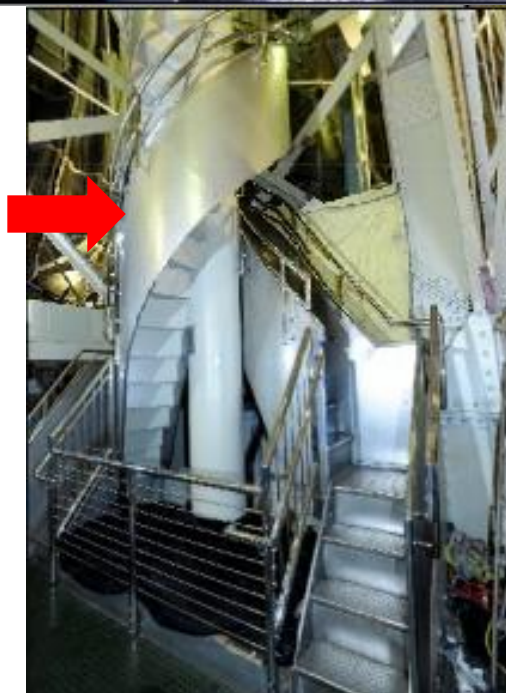
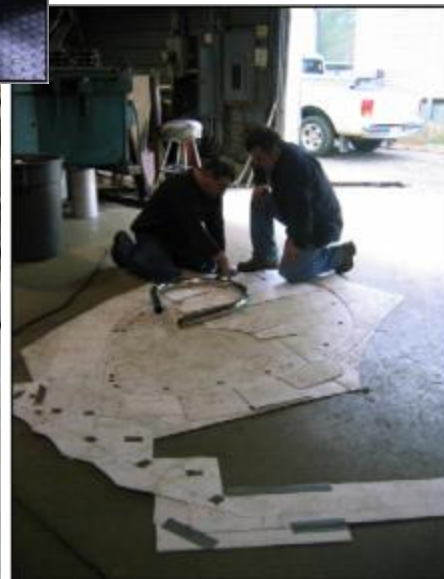
- New construction included fully compliant sprinkler system and standpipe in Pedestal. The Statue is still unsprinklered, with the exception of the two upright heads in the Crown which were reconnected during the new construction.
- New code compliant fire alarm system throughout the Pedestal. Analaser air sampling reconnected and corrected.
